Menkaure Valley Temple

The Great Pyramid Temple Project

Menkaure Valley Temple Season 2020

Volume 21 Numbers 1 & 2 Spring–Fall 2020

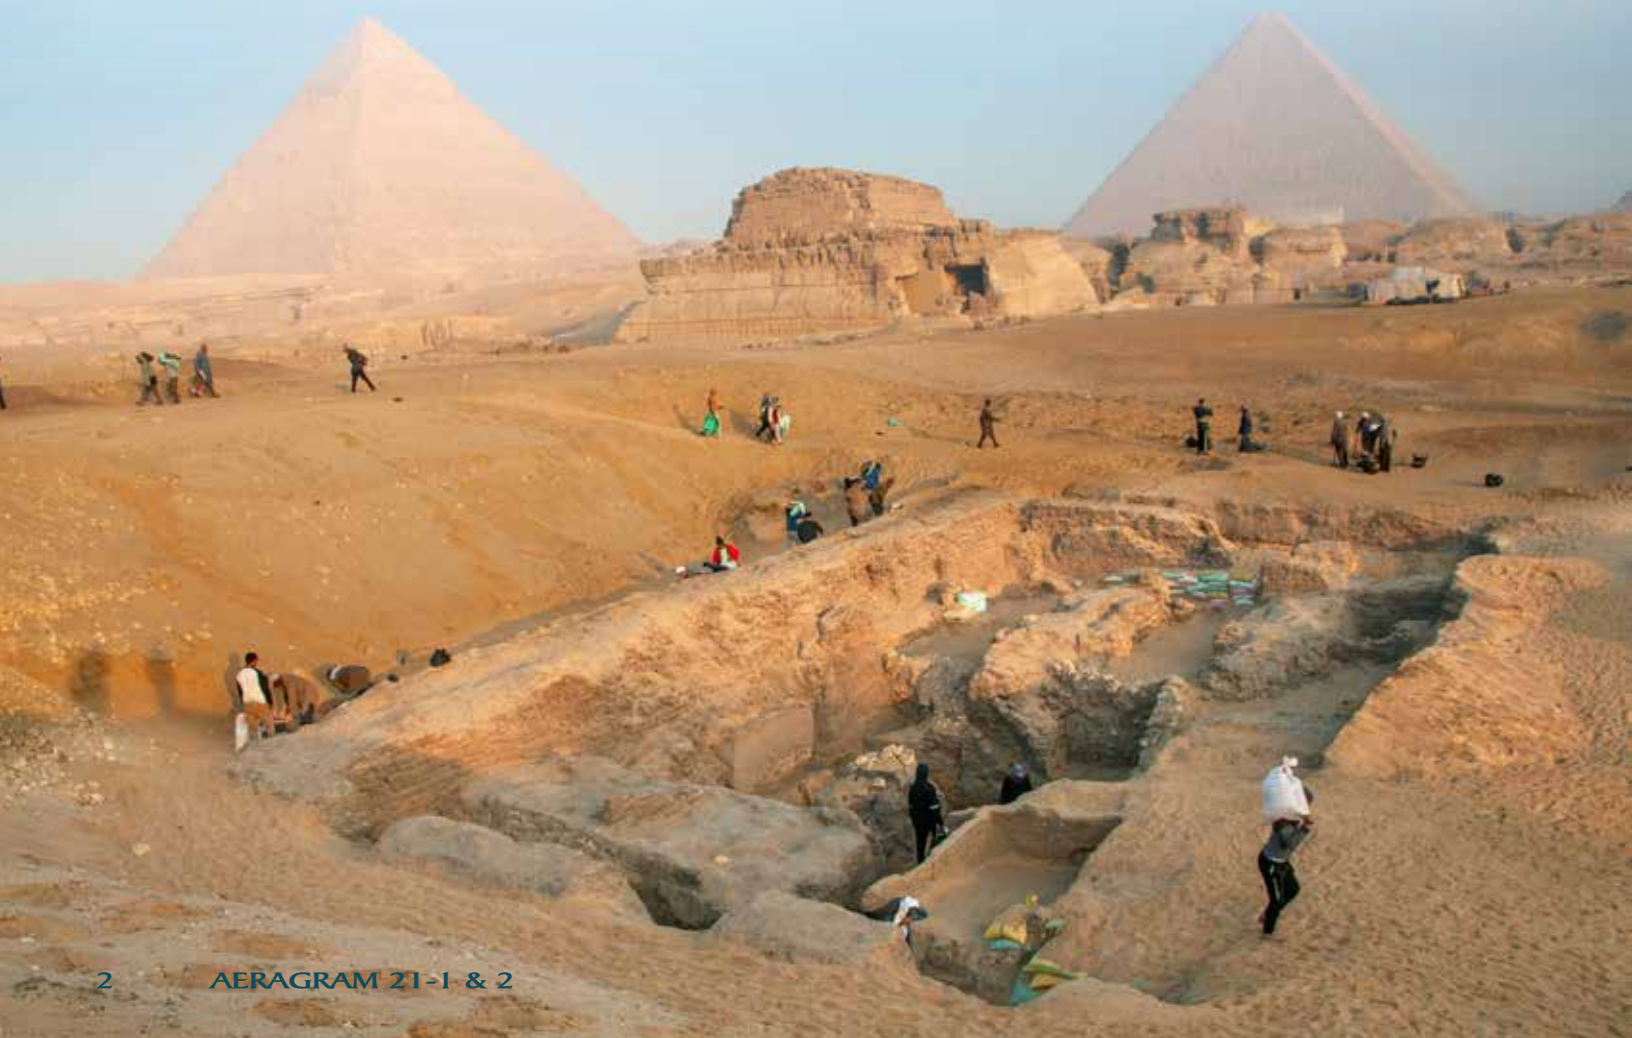
AERA excavations in progress in the Menkaure Valley Temple, west end, during the 2020 field season. The Khafre (left) and Khufu (right) pyramids stand in the background, with the Khentkawes Monument between them. View to the northwest. Photo by Mark Lehner.

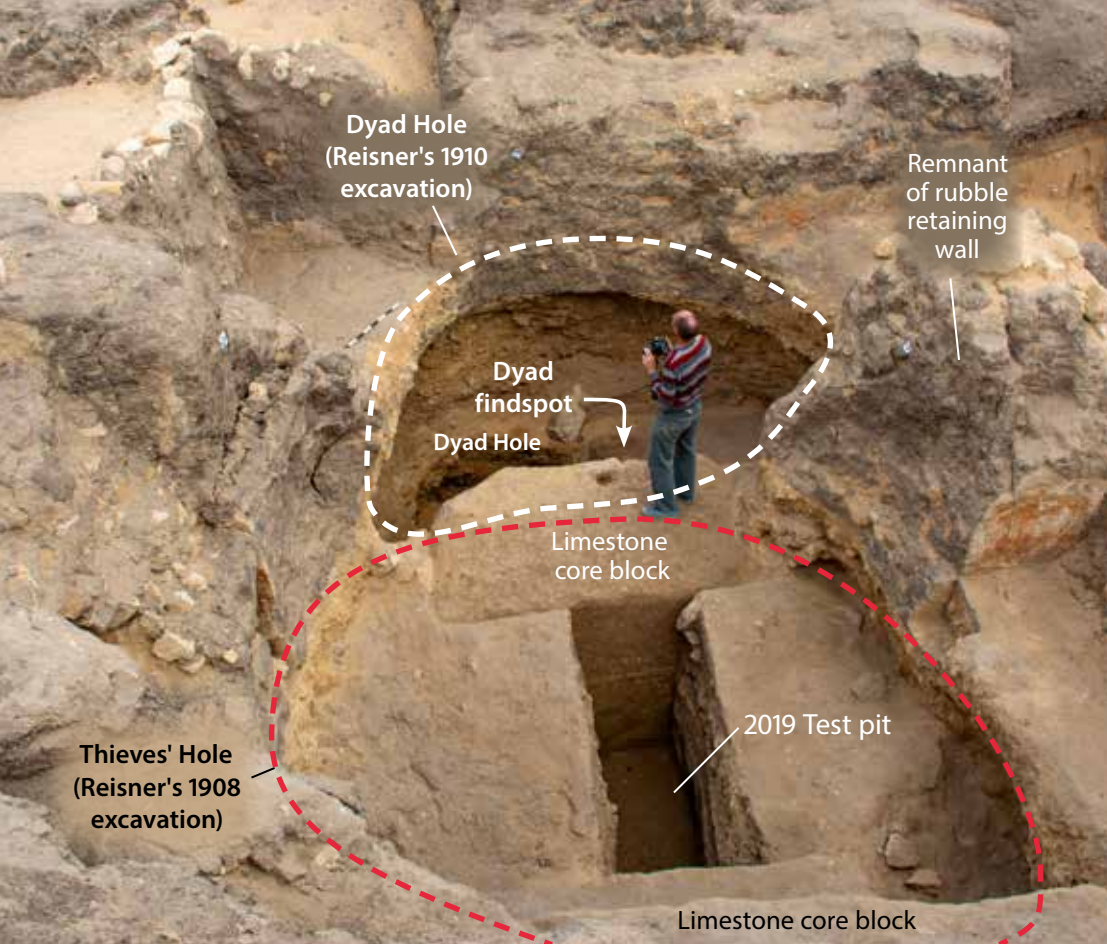
Excavations in the southwest corner of the Menkaure Valley Temple in 2019. Dan Jones photographs the Dyad Hole. View to the east-southeast. Photo by Sayed Salah Abd el-Hakim.

We determined the exact spot where the dyad stood in what we called the Dyad Hole by comparing Reisner's field photos of the discovery with features we could see on the adjacent limestone foundation blocks. When Reisner published the site, he conflated the two holes, and so he wrote that the dyad came from Thieves' Hole. In addition to the dyad, Reisner found statue fragments below it, but was not able to dig very far because of the water table.

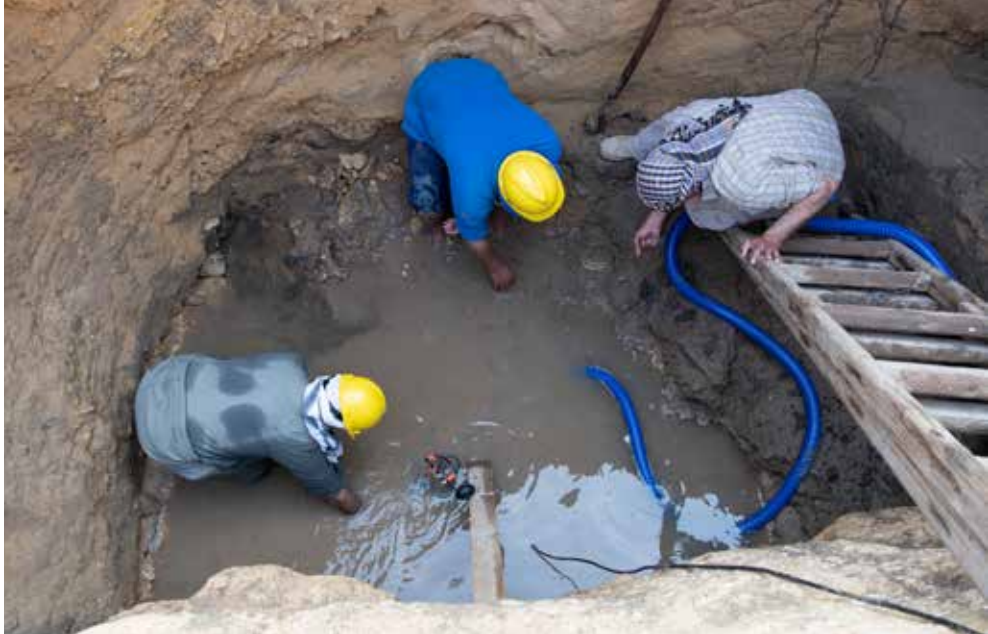
Sayed Salah (on ladder), Ramadan Hussein (left), and Emad Shabaan (center) work with the pump at the bottom of the Dyad Hole. View to the east. Photo by Mark Lehner.

During 2020 in our efforts to study Menkaure's foundation, we planned to examine the core block that was just barely exposed below the dyad findspot. But, like Reisner, we were thwarted by groundwater. We set up a pump to lower the water level, which slowly fell, for a time. But the pump was no match for the water; it soon rushed in (photo, page 4). We were able to pull a few small fragments of granite and diorite out of the muck, but failed to expose the core blocks below.

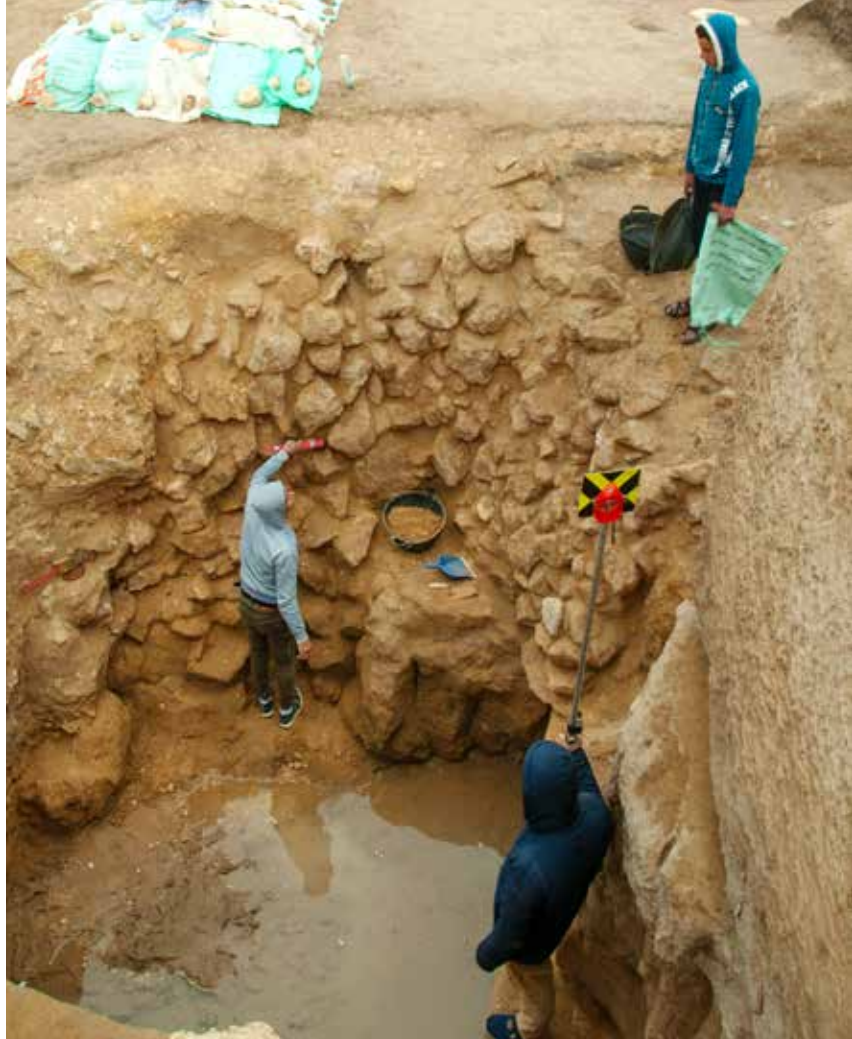
Top: The Northeast Hole (NEH). Survey Assistant Abass Eid Shabaan stands in the bottom of the hole as far as we could excavate. The water table prevented us from going any farther down. Workman Sayed Hani Abd el-Hakim brushes the retaining wall in preparation for photography and mapping. Note the limestone rubble retaining wall on the east and south side of NEH, similar to the one in Thieves' Hole. View to the east.

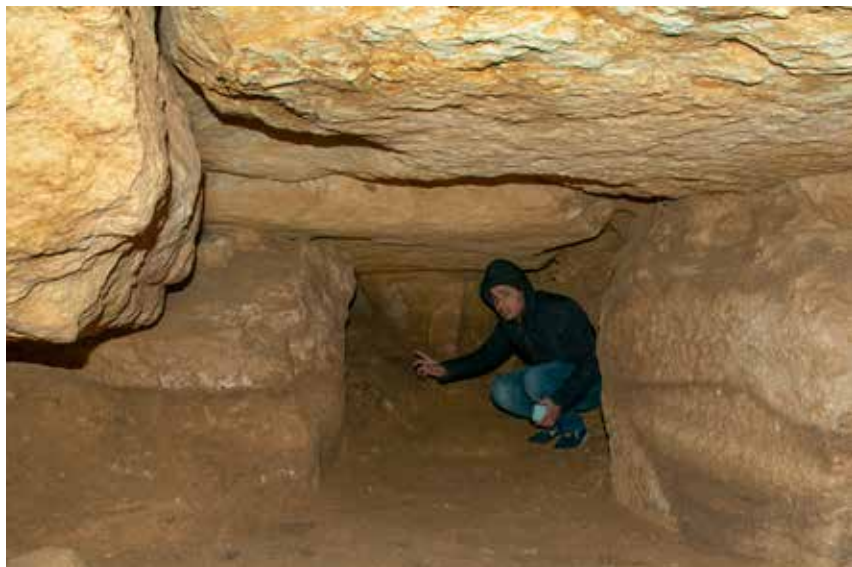
Above: Abass Eid Shabaan points to (ancient?) debris at the far end of the "tunnel" into the foundation of monolithic limestone blocks at the northeast corner of the MVT. The tunnel departs from the bottom of the NEH Hole. View to the south. Photos by Mark Lehner.

Someone burrowed through or between four of the temple’s limestone core blocks and tunneled south for nearly 6 meters (20 feet). Perhaps they cleared out limestone debris that Shepseskaf’s builders used to fill a gap that Menkaure’s builders left between the large core blocks when he prepared the unfinished foundation for the First Temple of mudbrick. This was suggested by crushed limestone and tafla (calcareous desert clay) lying along the margins. Inside the tunnel we could see six core blocks, three on either side. The blocks are gargantuan; two of them formed a sort of platform that measured 2.9 × 2.6 meters (9.5 × 8.5 feet). The floor of the tunnel, like the base of the NEH, was saturated with water.

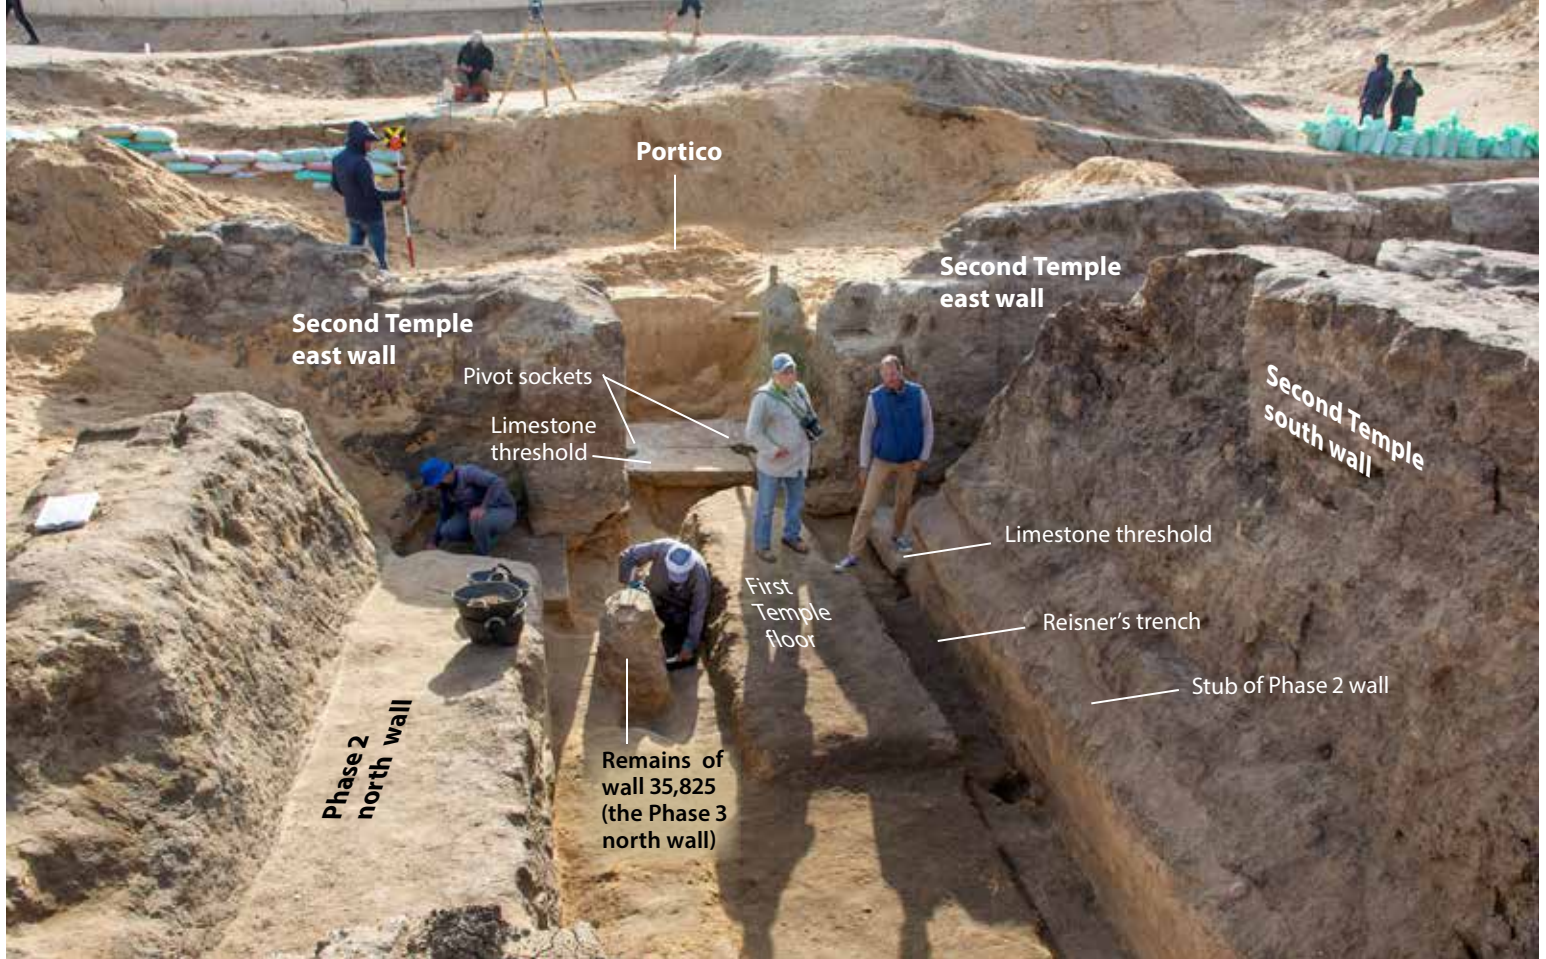
Above: The Offering Hall. Mark Lehner and Dan Jones (center) ponder the gutted hall that Reisner left. Dan straddles one of the trenches Reisner dug in order to look for the temple foundation. Note the great volume of clean sand Reisner deposited as backfill in the portico, in the background. The Offering Hall was also filled with clean sand, which preserved it in a state that looked much like the photos that Reisner took upon completion of his excavation. View to the east. Photo by Sayed Salah Abd el-Hakim.

Reisner began work in the Offering Hall in 1908, clearing the room down to the Second Temple floor. He found the walls standing tall and well preserved.⁶ Following his standard field practice, he documented the room with photos. They are the only record of much of that space as he found it. He dug out the floor of the Second Temple to reach the floor of the First Temple. He removed most of the northern wall and trenched the floor along the base of the walls in search of the foundation core blocks in order to trace the lines of the First Temple (photo, page 6). He also scraped off the face of the western wall and hacked two vertical trenches into it.

We took the opportunity to clear the Offering Hall even as we backfilled what we had cleared of the rest of the temple, three weeks sooner than planned. It was full of clean sand that Reisner's crew dumped in 1910. We found the hall looking much as it did in Reisner's final photos.

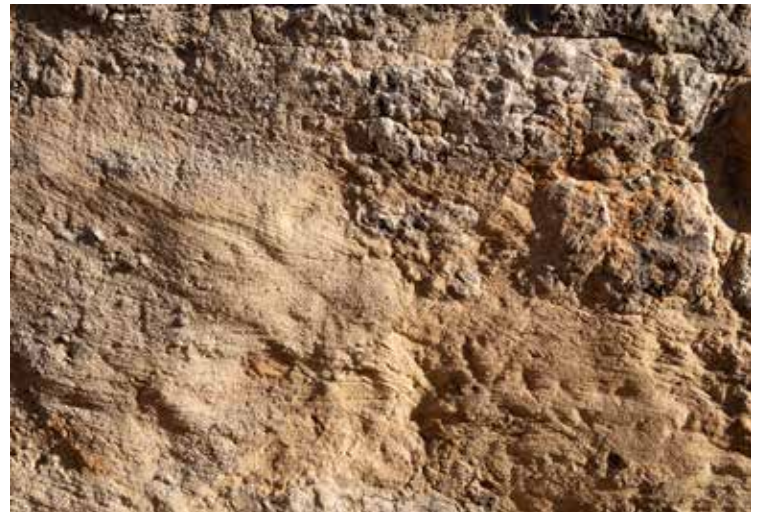
Right: Close-up of the Phase 2 north wall (35,839). Fine sand in the seams of the bricks deposited by streaming water indicates that the temple was left open and abandoned for some time. Photo by Mark Lehner.

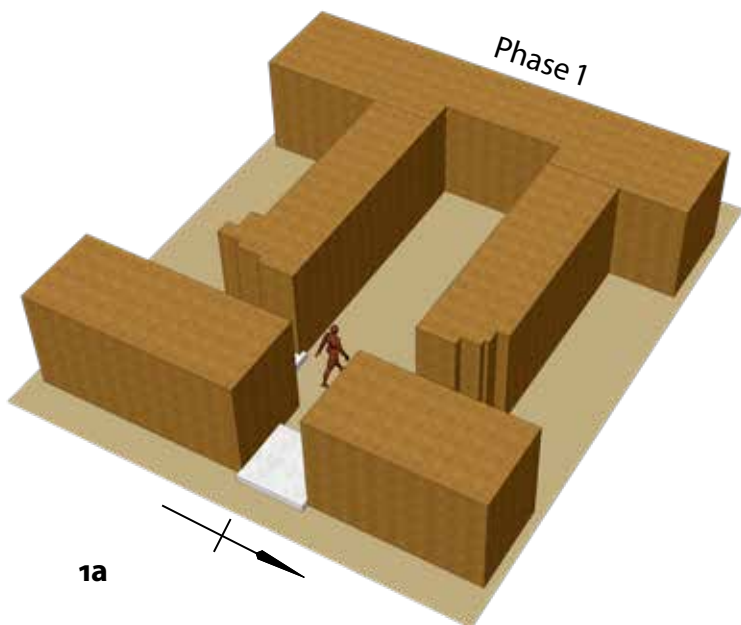
1a

1a) The mudbrick Offering Hall that Shepseskaf built following Menkaure's untimely death (shown with a human figure for scale). We found traces of these walls surviving to only a few centimeters high at the bottom of the stratigraphic sequence of wall rebuilds (shown below in 2).

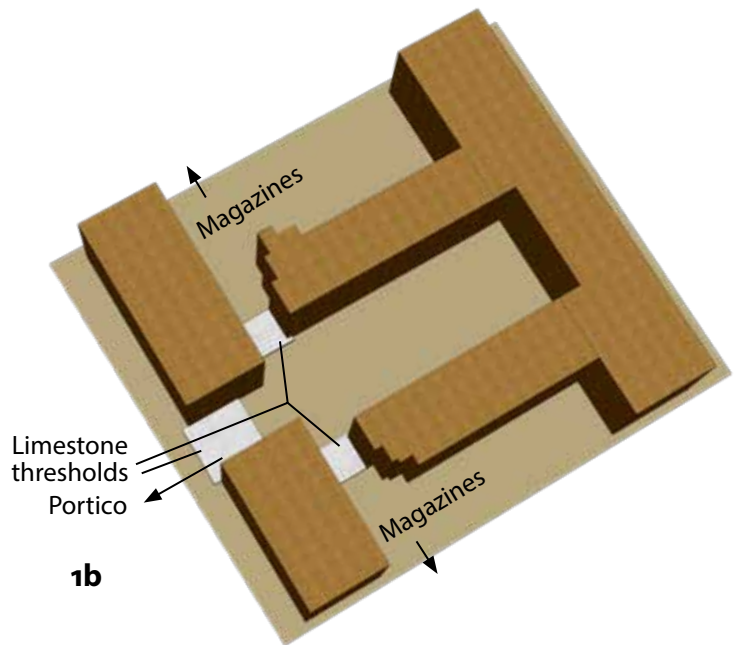
1b

1b) This first hall had three entrances, each with a limestone threshold. The northern and southern entrances had single-leaf doors, Reisner believed, based on the single pivot sockets in the thresholds. The doors opened into corridors that gave access to magazines to the north and south along the western wall. The eastern entrance, with two pivot sockets, and hence a double-leaf door, opened onto the portico, which overlooked the court.

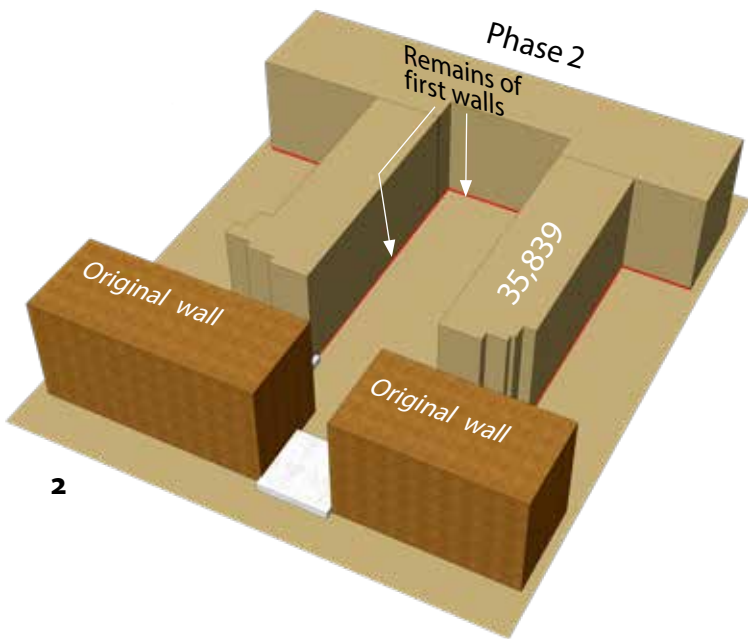
2) At some point, a flood, or other catastrophe, so badly damaged the First Temple sanctuary that the temple caretakers rebuilt the walls, setting them directly on the footprint of the first walls. The builders probably leveled what remained of the oldest walls to form a foundation for the new set of walls. In the model of Phase 2 the remains of the first walls are shown as thin bands at the bottom of the new north, south, and west walls. The original east walls apparently remained standing, as we found no evidence of rebuilding.

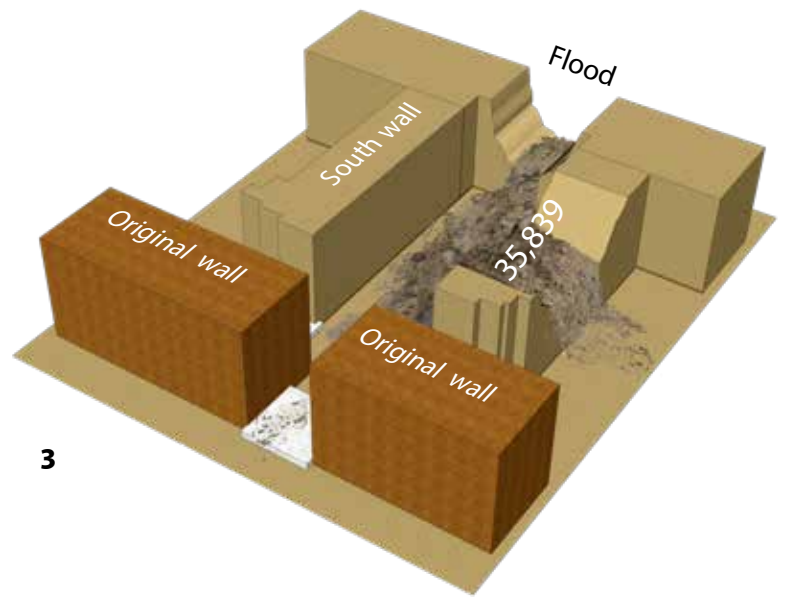
3

3) Sometime after the new walls were erected, another (?) flash flood tore through the back wall of the Offering Hall (the MVT western wall) and apparently rendered the temple uninhabitable. The hall stood open—the roof presumably having collapsed—and abandoned long enough for the bricks of the northern wall (35,839) to develop a crackled crust, and for streaming water to leave fine sand in the seams (see photo, facing page). We don't see the same weathering in the southern wall, because plaster still covers much of what survived of it. Elsewhere in the MVT there were signs of extensive plundering, as reported by Reisner, another indication that the temple must have been abandoned and open.

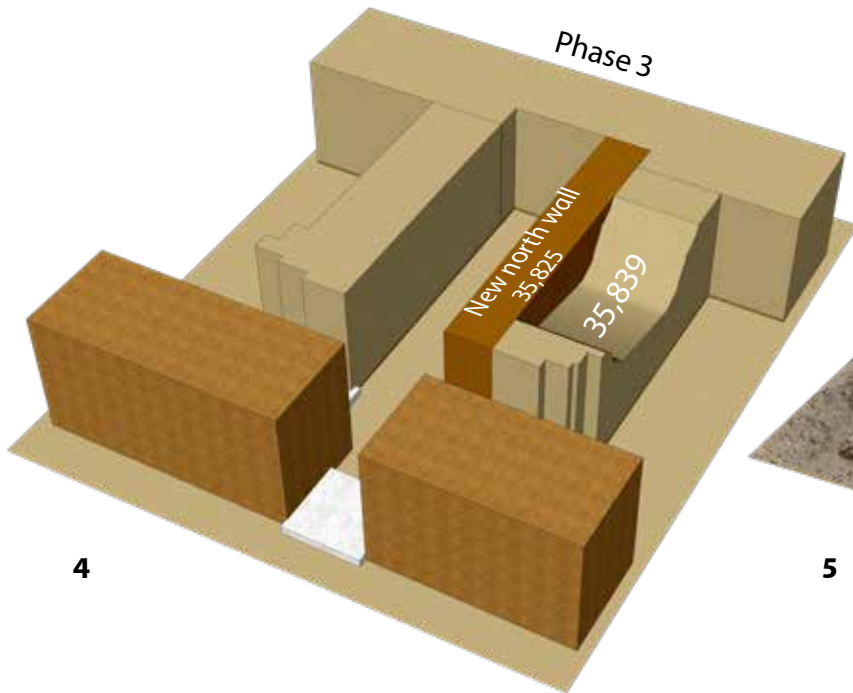
4

4) The damage to the north wall was apparently extensive enough to call for a new wall. The people restoring the temple built a new northern wall next to the old damaged one. This new wall reduced the width of the Offering Hall from 3 to 2.15 meters (9.8 to 7 feet). Reisner believed that the new north wall was built as part of the Second Temple, and he missed a phase in the complex history of the MVT.

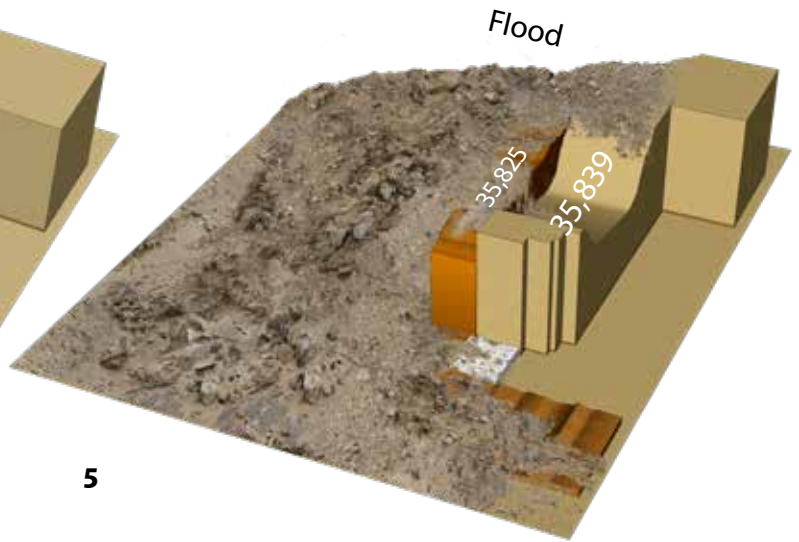
5

5) The First Temple period came to an end when yet another devastating flash flood ripped through the back wall, tore through the Offering Hall, and pooled in the court. The torrent of floodwater left coarse limestone debris, fragmented mudbricks, and sand in its path. When the temple was resurrected during Pepi II's reign, builders constructed new walls on the south, west, and east sides of the temple as a whole (shown in 6).

The major flood event that Reisner saw breached the west wall of the temple and ended the second phase of the Offering Hall (page 8, model 5), a rebuild following a flood Reisner missed (model 3). We see evidence of yet another event that interrupted the temple in its earliest phase, the true First Temple (Phase 1). The walls of this oldest Offering Hall survive to only a few centimeters high at the bottom of the sequence.

1. The flood that tore out much of the back wall (model 5, facing page) and brought down the First Temple did not inflict much damage on the north side of the room. The west wall (models 2–5, photo above right) was preserved to some height, not torn out, along the northern side of the flood breach. The floodwaters flowed in an east-southeast direction, attacking mainly the south side of the room. The flood debris probably scraped wall 35,825, but did not destroy it.

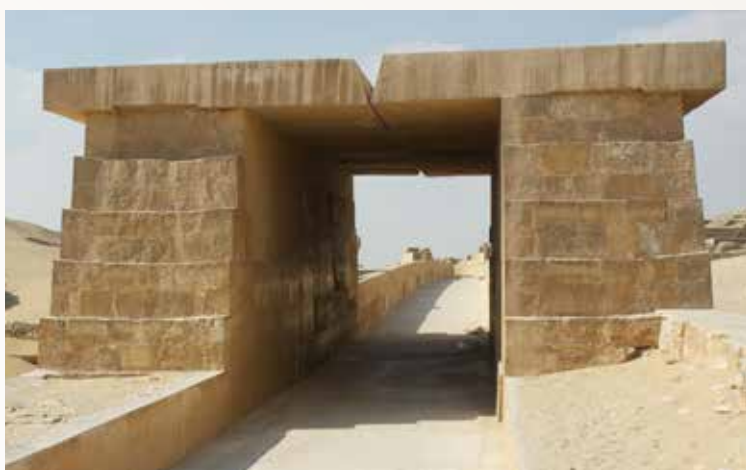
Left: The causeway of the 5th Dynasty pyramid of Unas at Saqqara, with reconstructed roof of limestone slabs that left a light slit above the center of the corridor. Khufu's causeway corridor may have had a similar roof with a slit for light.

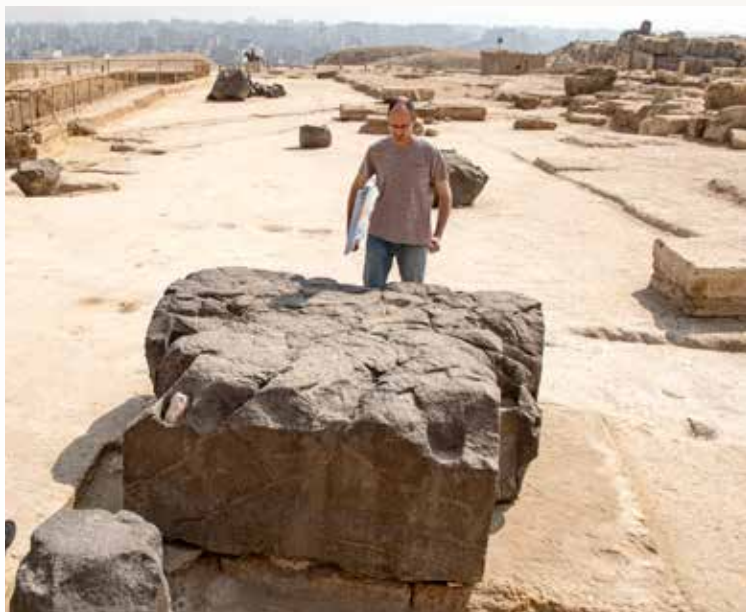
Below left: Dan Jones examines the black basalt entrance threshold of the Great Pyramid Temple. The causeway ran east behind him. View to the east. Photos by Mark Lehner.

The basalt block of the eastern entrance threshold remains in place where the causeway connected to the temple. On it we can see pivot sockets for a wooden double-leaf door that swung open like an American Old West saloon door to give access into the temple. If the causeway had been roofed and poorly lit, the effect on entering the open court would have been startling, blinding. Sunlight blazed down on the burnished black basalt floor and reflected off the polished white casing of the Pyramid towering above—a gigantic special-effect wrought in stone.

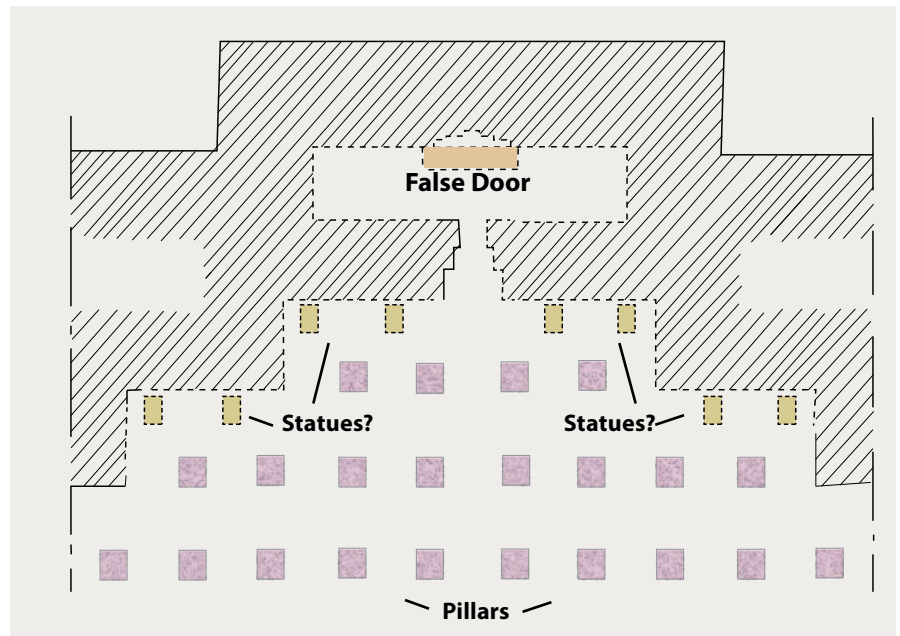
Above: Statues of Khufu might have been installed in the west bay of his upper pyramid temple (after Lauer 1949, fig. 1). Lauer also shows the possibility of a false floor in the center back wall of the temple sanctuary, where people could place offerings on a slab, and through which Khufu could magically come and go from his Great Pyramid.

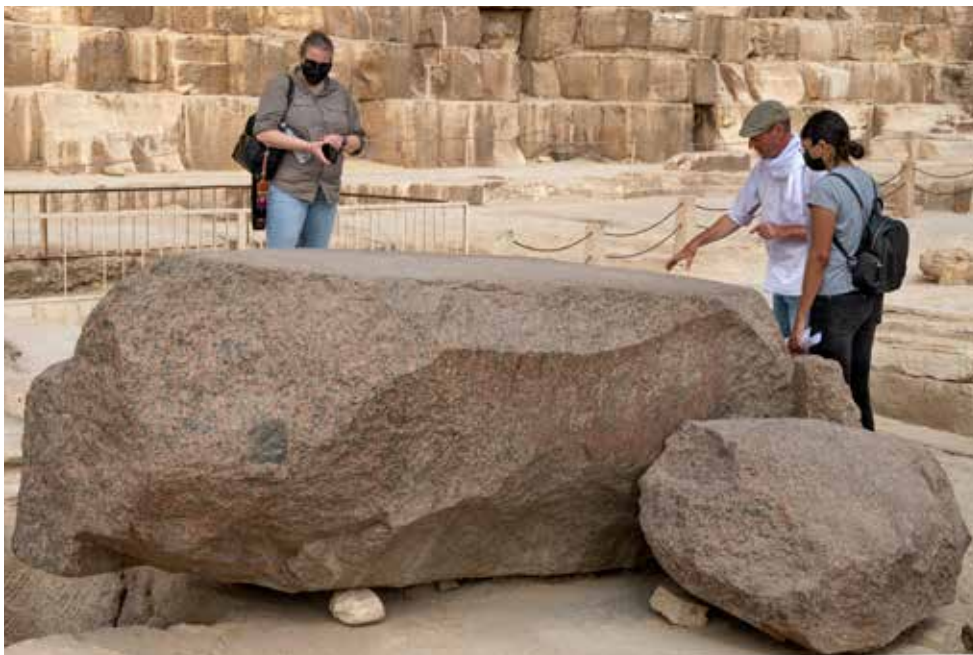
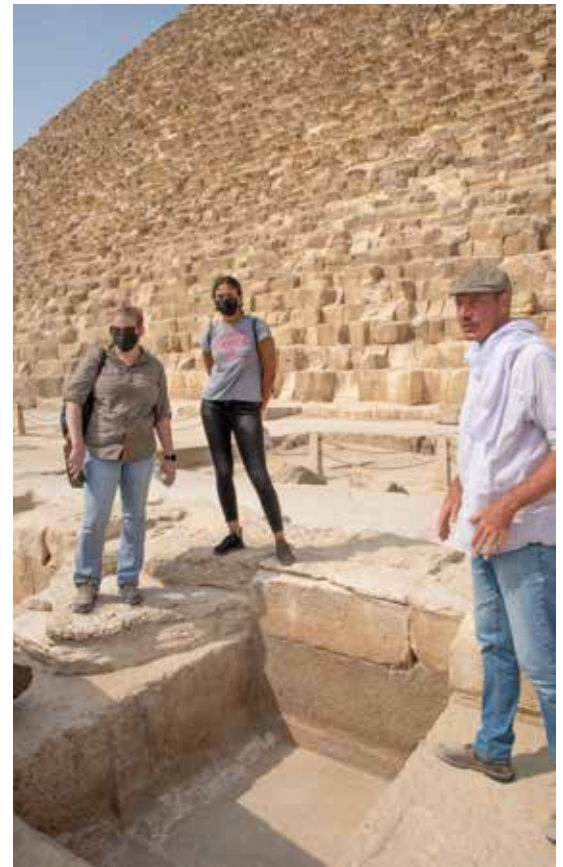
Above: Dr. Louise Bertini, Mariam Foum, and Dan Jones examine a granite pillar. Right: Here they look at the socket in which this pillar might have stood. Below right: In Roman or Saite (26th Dynasty) times someone cut this shaft into the Great Pyramid temple sanctuary down along two prominent natural fissures. After clearing the temple and shaft between 1938 and the early 1940s, the antiquities authority installed a metal door across a passage leading to the shaft and a metal railing around its perimeter. Photos by Mark Lehner.

as a well or an unfinished tomb, into the center of this sunken foundation. This season we hired a crew with a motorized winch to take out many years of accumulated trash and clear the shaft to its bottom, more than 16 meters (52 feet) deep.

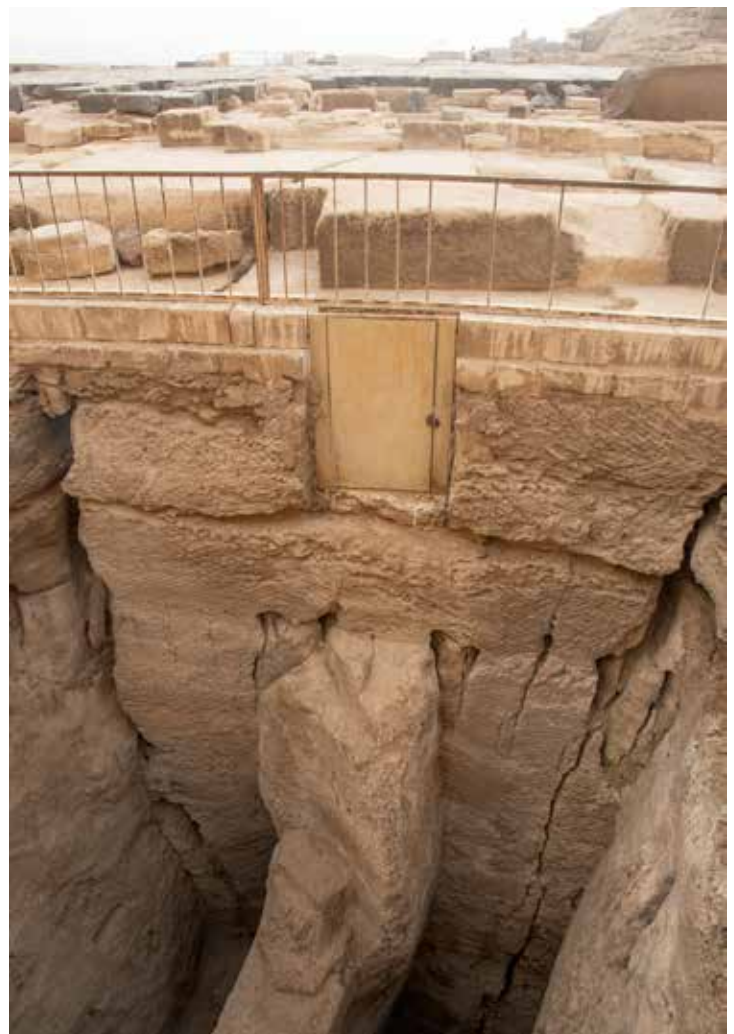
Above: View to the north of the limestone bedding below the basalt pavement. Photo by Mark Lehner.

For the basalt court pavement, workers prepared a bedding of limestone pieces and gypsum mortar, cut to conform to the angular bottoms of the basalt floor slabs. Basalt is a magmatic, volcanic rock² with a hardness of 6 on the Mohs hardness scale (resistance to being scratched); granite being 6 to 7, diamond 10, while limestone is only 1 to 3. When the magma flow cooled and hardened into black rock, it fractured in conchoidal or angular surfaces. Quarrymen took pieces from natural cleavages with angular facets.³ At Giza, Khufu's masons left those angular facets on the undersides of the pieces as they carefully

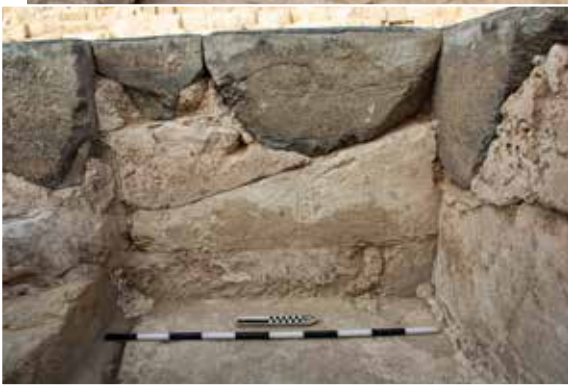
Inset: The west side of a pillar socket showing the hole cut into the bedrock for the pillar, the stones packed around the hole, and the limestone bedding laid to accommodate the basalt pavement placed on top of it. Photo by Mark Lehner.

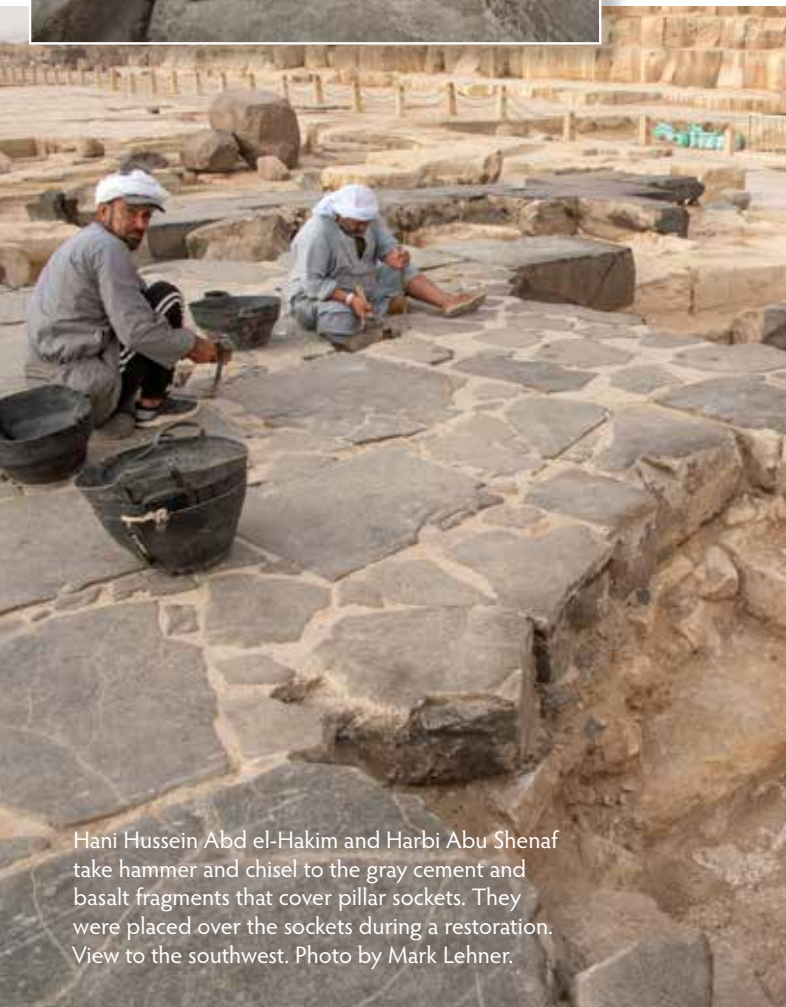
Hani Hussein Abd el-Hakim and Harbi Abu Shenaf take hammer and chisel to the gray cement and basalt fragments that cover pillar sockets. They were placed over the sockets during a restoration. View to the southwest. Photo by Mark Lehner.

Ashraf Mohedein, General Director of Giza, gave us permission to remove the restoration over the three sockets, so we could complete our documentation. Underneath, we found sandy debris. As we removed it, we were surprised to find limestone pieces with remains of relief-carved decoration in each socket. These pieces must come from the inner walls around the court. It appears that ancient material filling these pillar sockets was never removed before being covered. It makes us wonder whether more unexcavated material lies below the rest of the restoration.

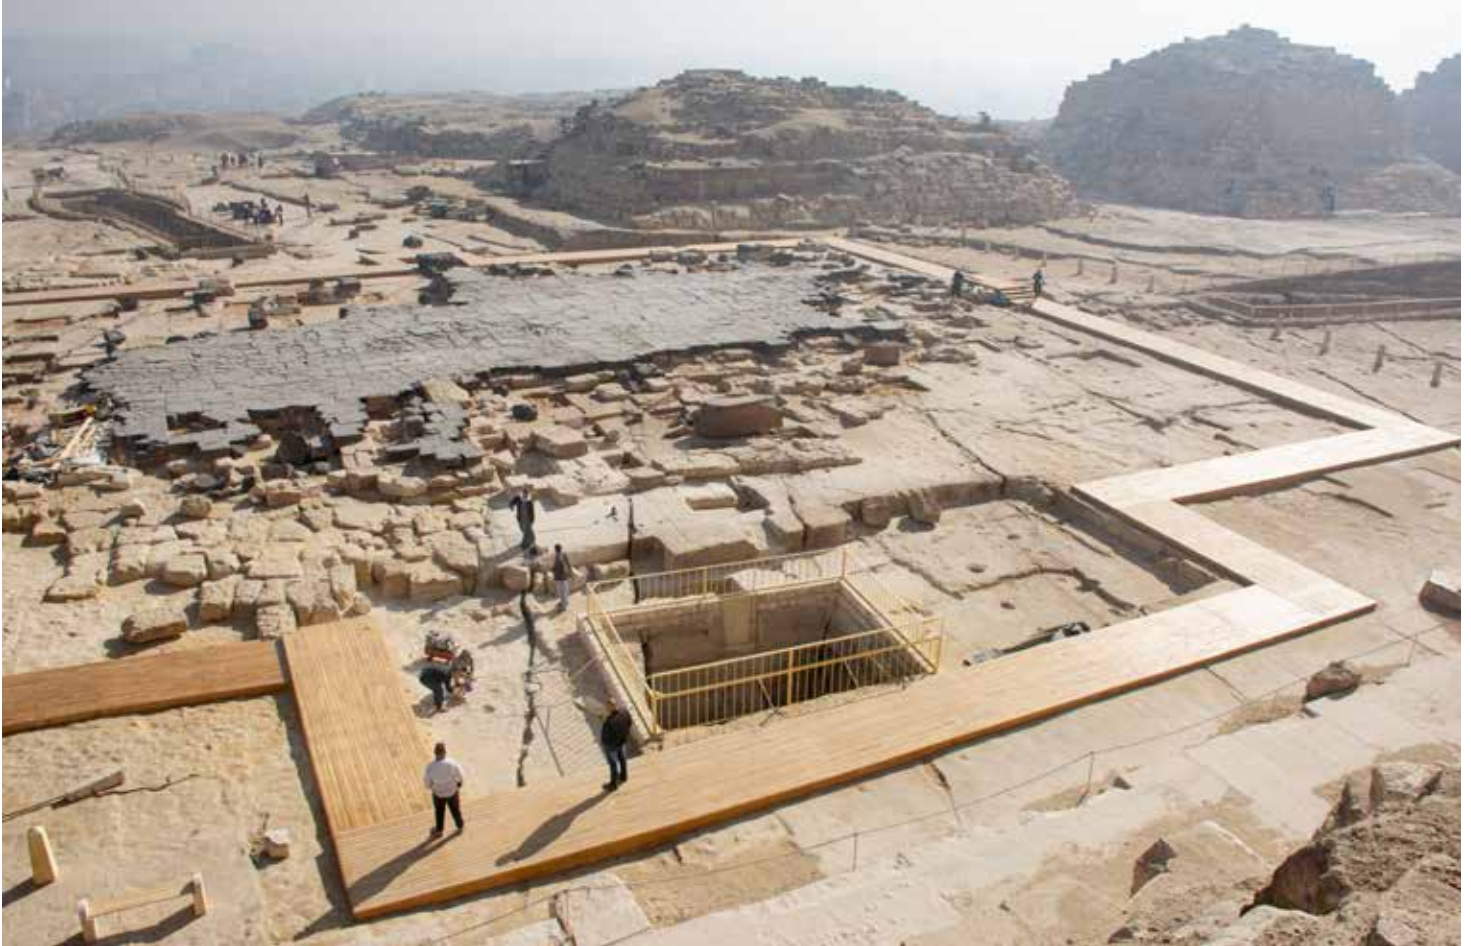
Above: The Great Pyramid Temple walkway completed. In the foreground, the walkway runs along the west side of unfinished tomb shaft. Queens' pyramids stand in the background. View to the southeast. Photo by Sayed Salah.

Right: The walkway around the Great Pyramid Temple under construction. Workers pour sand into the walkway frame to provide support. The wooden frame, 2.06 meters (6.75 feet) wide and 0.15 meters (6 inches) high, sits directly on the limestone bedrock and archaeological remains. To support the frame and the planks that would go over it, crossbeams were fixed with metal brackets, treated to prevent rust, to the inside of the frame. Swedish pine was used for the frame and crossbeams. View to the northwest. Photo by Dan Jones.

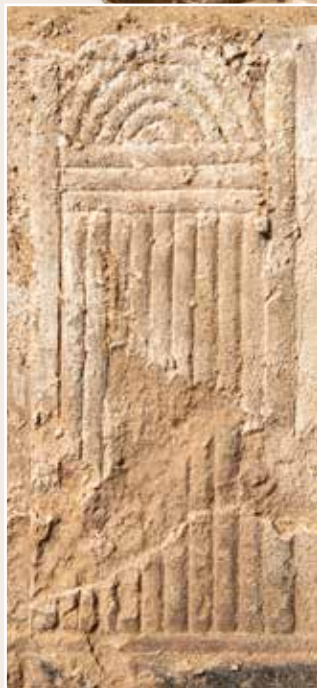
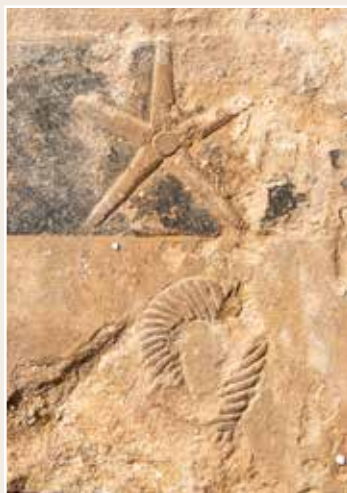
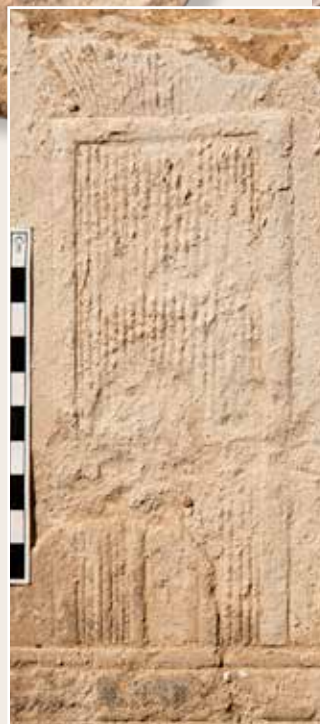
Left above: Block with painted and relief-carved decoration showing booths lined up for the Sed Festival, traditionally a king's jubilee of 30 years of rule, above a black band studded with stars. Inset far left: From the Great Pyramid Temple relief, one of a series of shrines of Lower Egypt, sometimes known as *Per Nu*. Inset center right: Top of a loop of rope may have been part of the hieroglyph for *za*, "protection." Inset right: One of two booths preserved at the right end of the piece with a cavetto cornice, symbolizing shrines of Upper (southern) Egypt, sometimes called *Per Wer*. Photos by Mark Lehner.

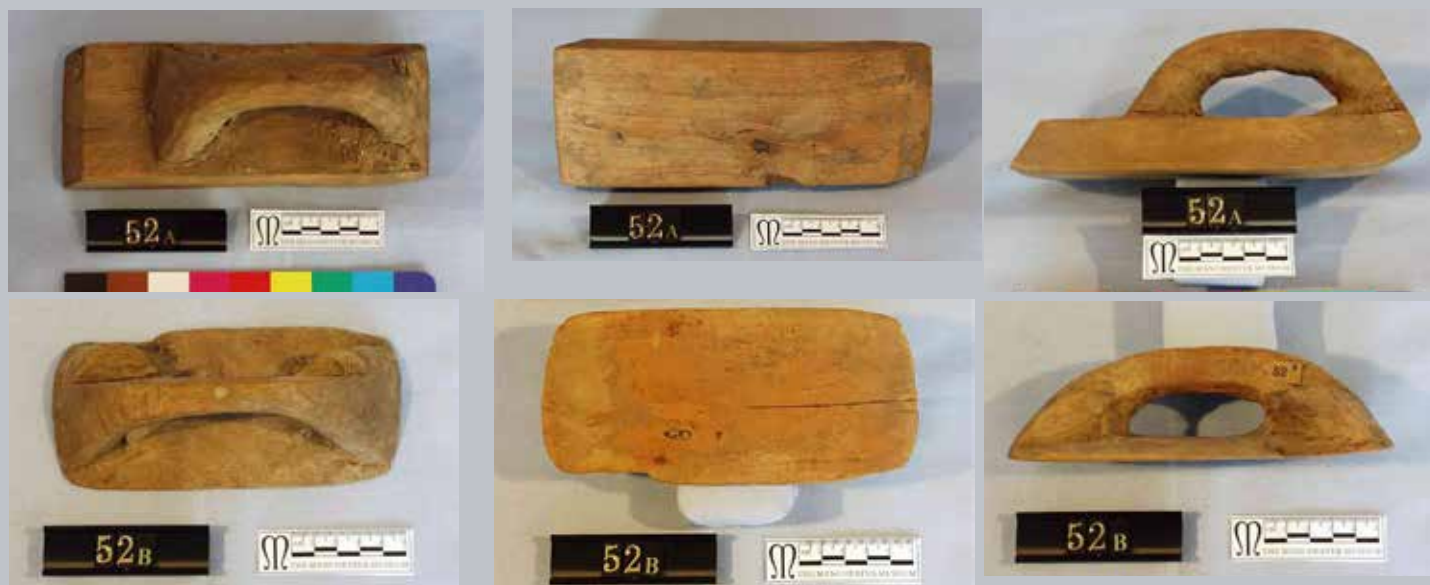
Two wooden floats from the 12th Dynasty pyramid town at el-Lahun. They were made of a single piece of wood, and both surfaces are perfectly flat. The larger one, 52A, was for the rough coat. The beveled end that projected far out from the handle was evidently used to get into corners without disturbing the coat on the adjoining wall. The smaller float (52B) is lighter and smoother and was used for applying the final coat. Both floats were found covered with mud plaster and even pieces of chopped straw. Courtesy of the Manchester Museum.

No plasterers' floats dating from the Old Kingdom have been found so far. Petrie discovered two floats at the Middle Kingdom pyramid town of Senusret II at el-Lahun,⁴ but I believe floats were used as early as the Predynastic period. The el-Lahun floats—very similar to those of the present day—are now at the Manchester Museum (photos, page 21).

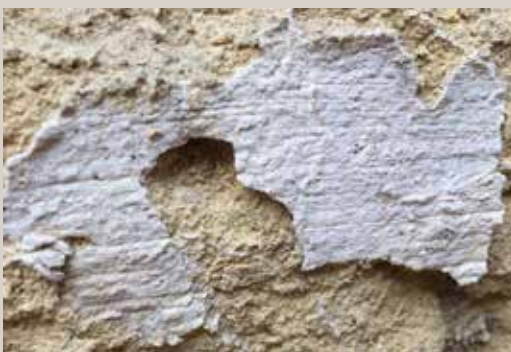
a) Plaster on MVT causeway corridor

a) and b) Plaster on mudbrick showing horizontal striations and ridges left by a plasterer's float. a) White plaster on east face of the wall in the causeway corridor of the Menkaure Valley Temple; b) Mudbrick fragment from the Kromer Dump; c) Plaster fragment with scattered white dots on the surface left by a reed brush. Photos by M. Yahata.

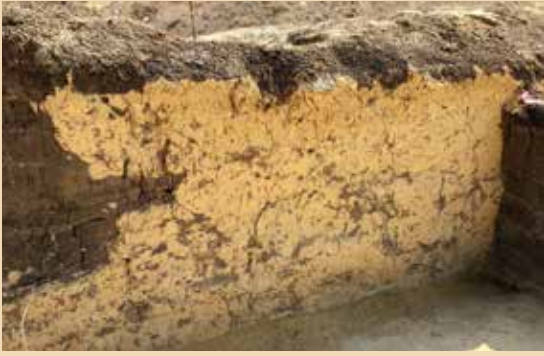
1. Single Coat of Yellow Marl Clay (Tafla) Plaster

Yellow marl clay (tafla) plaster applied to a wall in the MVT Annex without painted plaster.

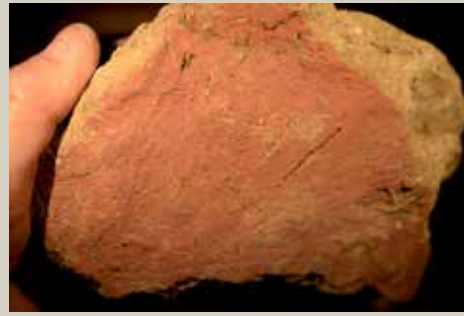
2a. Left: **PL93.** From KRO, a wall fragment with red paint, with the plaster applied over a mix of marl clay and alluvial mud with much chopped straw. Right: **PL45.** From KRO, dark red paint applied over marl clay mixed with much chopped straw.

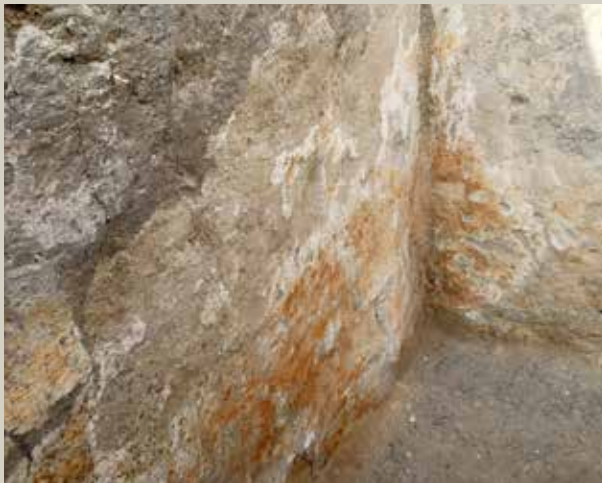
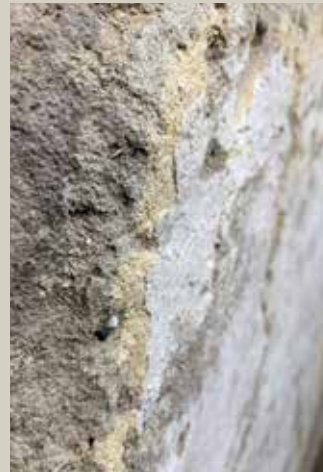
2b. MVT Causeway Corridor.

Red plaster applied over white plaster, which covers yellow marl clay plaster on a wall in the MVT Causeway. The rust red color is probably from hematite that was oxidized. This color is not seen in other AERA excavation sites or mudbrick fragments from KRO.

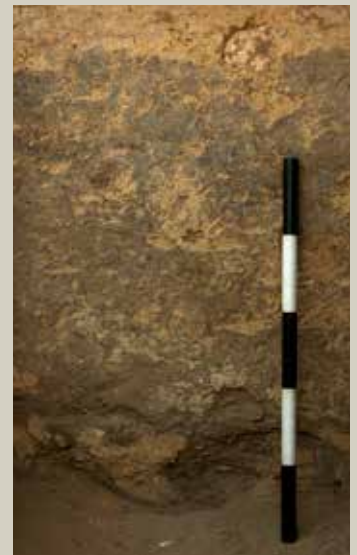
2d. Dado. Black-painted plaster remains on a wall in AA-S at HeG up to 25 inches (64 centimeters) high. Black paint on the lower part of the walls is known as a dado and very often can be seen in tombs in the Old and New Kingdoms. Photo by Aly Ahmed Aly Abdel Latif.

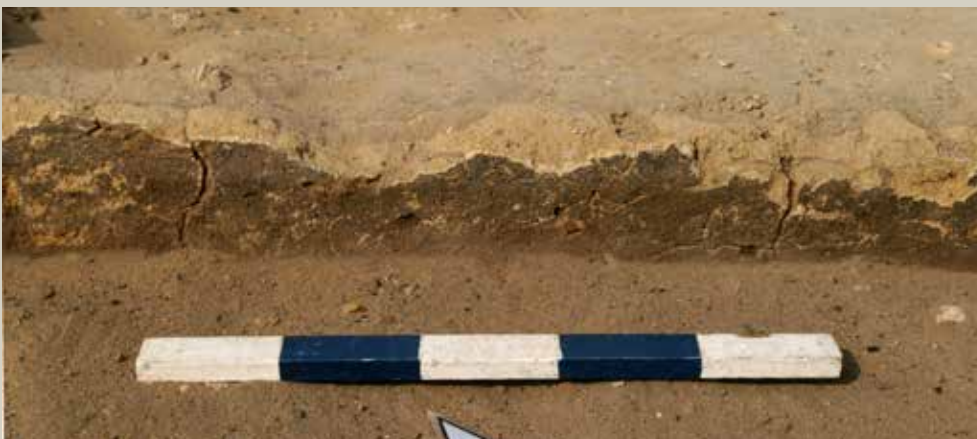
Dado. Traces of a dado on the wall in situ in House Unit 1 at HeG. The grayish-black layer (3 millimeters thick) was applied over a thin layer of white painted plaster, which was applied over yellow marl clay.
